ACTION MEMORANDUM

SUBJECT: Approval and Funding for a Removal Action at the Red and Bonita Mine Site in San Juan County, Approximately Seven Miles North of Silverton, Colorado.

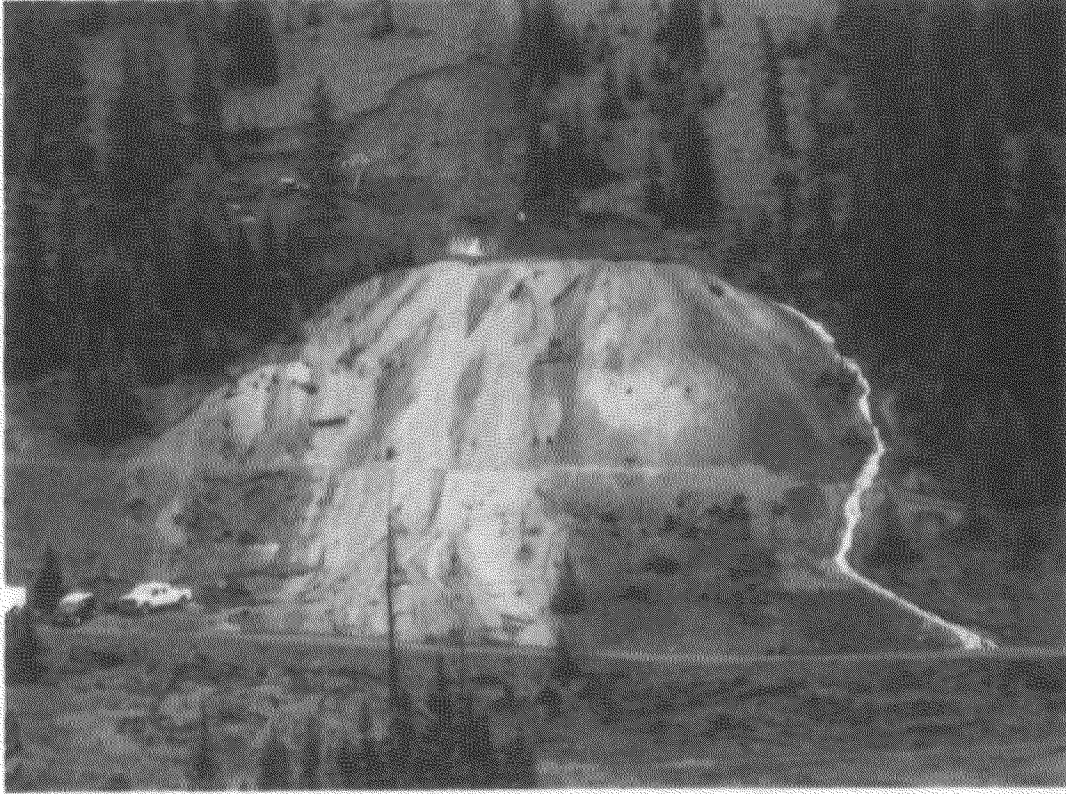
Red and Bonita Mine tailings dump view

The Red and Bonita Mine Site consists of approximately 1.25 acres of waste rock and suspected tailings material and includes an estimated 3,500 feet of underground workings (Stover 2007). The adit, which drains approximately 300 gpm throughout the year with some fluctuations seasonally, discharges to Cement Creek after crossing through a wetland. Prior to the removal assessment work, the mine water discharged through rock debris, as a result of a tunnel collapse that occurred decades ago..
